# **LOUISIANA DEPARTMENT OF WILDLIFE & FISHERIES**

**CANEY CREEK RESERVOIR**

**AQUATIC VEGETATION TYPE MAPS  
AND NARRATIVES**

## APPENDIX III – TYPE MAP HISTORY

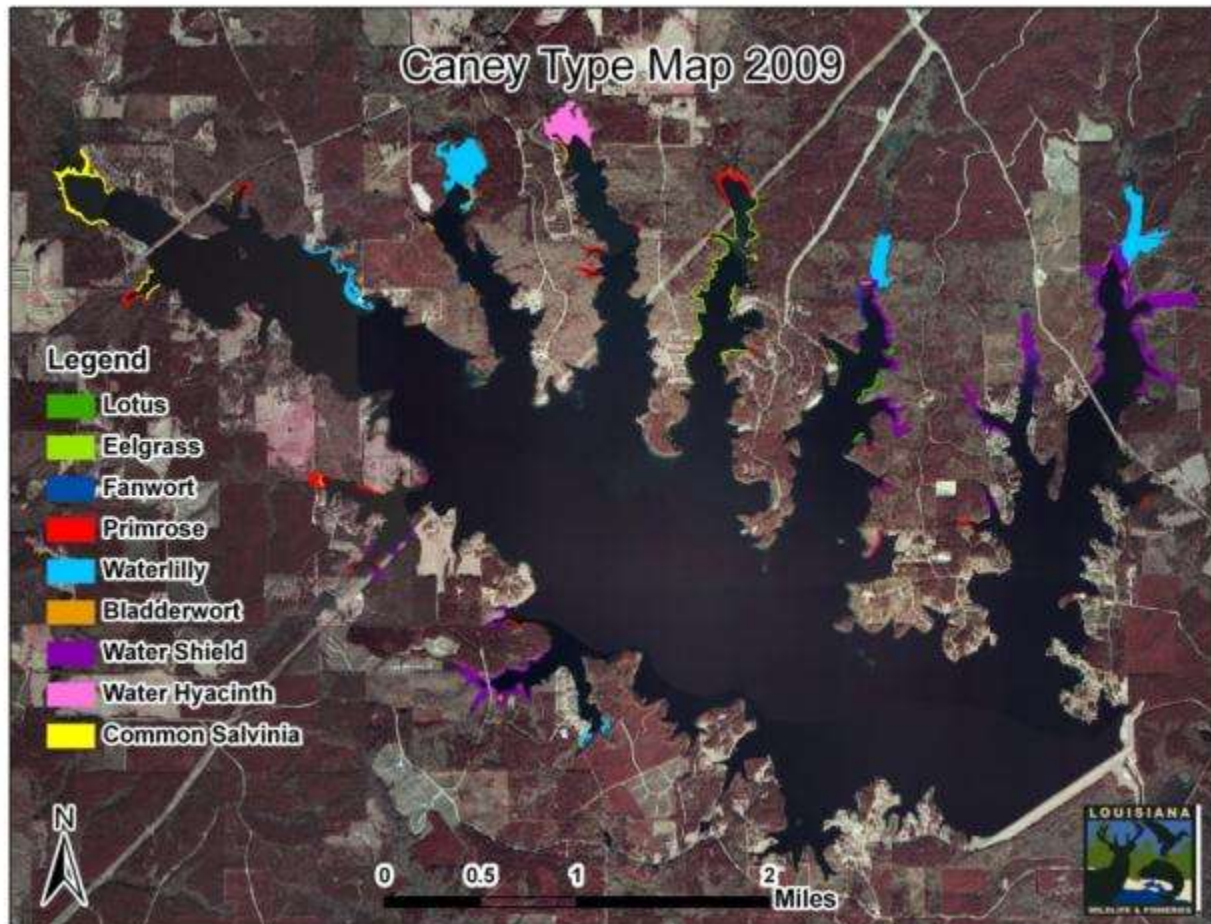
## Caney Lake – Aquatic Vegetation Type Map – 2009

American Lotus- 4.75  
Common Bladderwort- 4.99  
Fanwort- 3.28  
Eelgrass- 9.05  
Common Salvinia- 10.06  
Water Shield- 87.54  
Water Hyacinth  
Primrose- 16.31  
Water Lilly- 80.29
